Manhole Inspection Summary

Manhole # S27A1_001MH

Insp Date: **4/18/08 1:10 PM**

Location Address: **Manokin St**

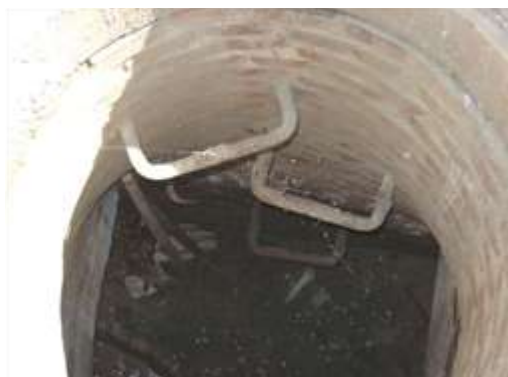
Defect 6

Steps Count: **4** Missing: **1** ☒ **Corroded**

corroded steps

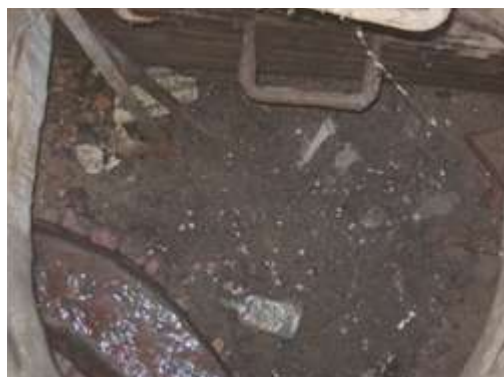
Defect 5

Condition: ☐ Sound ☐ Cracked ☐ Root Intrusion ☐ Deteriorated ☐ Leaks ☒ **Debris**

Debris on bench

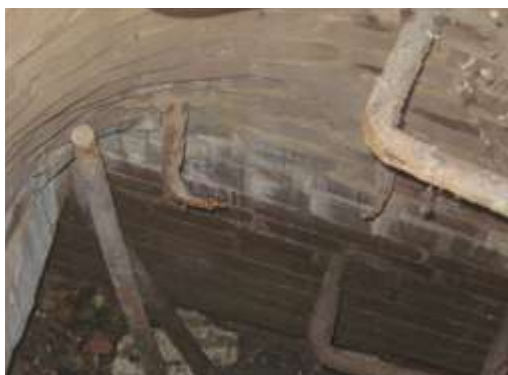
Defect 4

Surcharge ☒ **Evidence Of Surcharge** Depth: **1** (ft.) ☐ Active Surcharge Present

surcharge of evidence and corroded steps

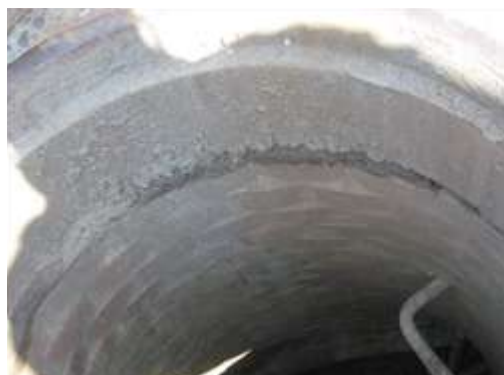
Defect 3

Infiltration: ☐ None ☐ Joint ☐ Cracks ☒ **Mortar** ☐ Roots ☐ Wall

Infiltration: ☐ None ☐ Joint ☐ Cracks ☐ Mortar ☐ Roots ☒ **Wall**

chimney and corbel infiltration

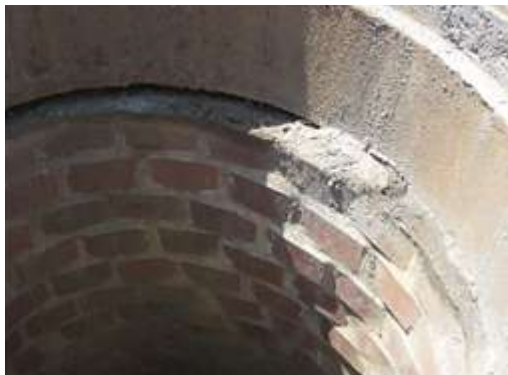
Defect 5

Frame Offset: **0.5** (in.) Condition: ☒ Sound ☐ Cracked ☐ Leaks

0.5 offset

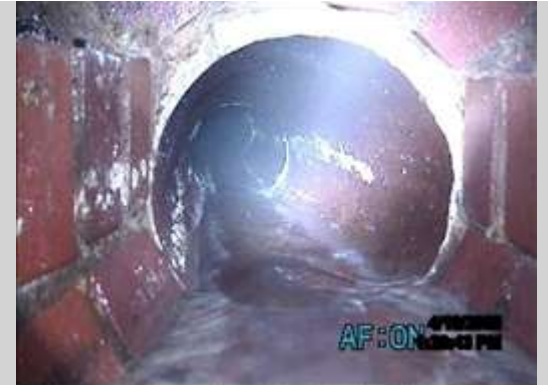
12 O'Clock Outflow

Pipe Height: **8.4** (in.) Rod and Bar (Angled)
Pipe Material: **Clay** ☐ Pipe Lined
Invert Depth: **8.27** (ft.) Flow Characteristics: **Fast**
Deposits: ☒ None ☐ Mud ☐ Sludge ☐ Debris ☐ Grease
Silt Depth: **0** (in.) Deposits Extent:
Infiltration: **Evidence** Pipe Seal Cond: **Unknown**

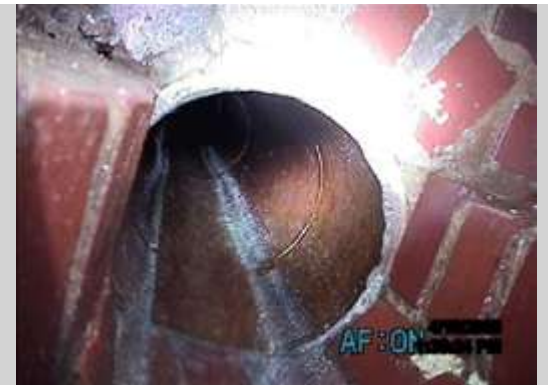
7 O'Clock Inflow

Comments **7 oclock measurement was a direct measure due to construction of channel**

Pipe Height: **3.6** (in.) Direct (Angled)
Pipe Material: **Clay** ☐ Pipe Lined
Invert Depth: **7.19** (ft.) Flow Characteristics: **Fast**
Deposits: ☒ None ☐ Mud ☐ Sludge ☐ Debris ☐ Grease
Silt Depth: **0** (in.) Deposits Extent:
Infiltration: **Evidence** Pipe Seal Cond: **Unknown**
